# Preliminary Site Investigation

Magor Site  
Newport

ABInBev

September 2021

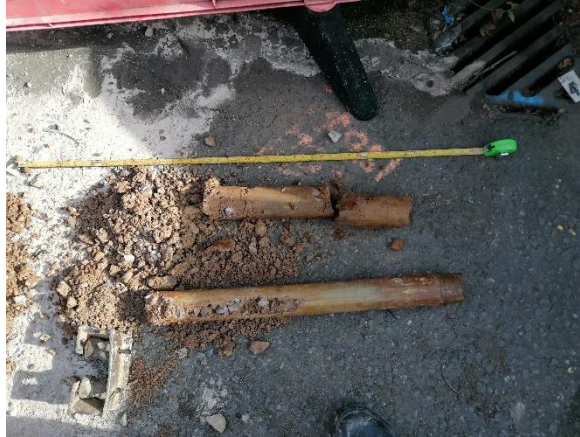
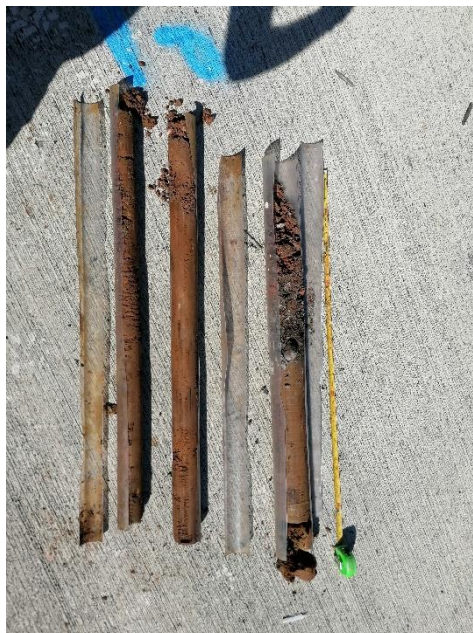
Sample cores

Beneath that there was superficial geology of slightly sandy, slightly gravelly clays stiff becoming softer with depth and increased moisture content. Rootlets and organic matter were found throughout.

WS11 was progressed to 3m depth with thicker superficial deposits (clayey gravelly sands) overlying a red/purple/grey silt/sandstone 2.95m with weathered rock fabric evident.

Highly weathered bedrock comprised grey/red brown mottled clay/silt with highly variable patches of harder mud/siltstone.
